Valley gutter joint repairs

ID: 9952

Industry: *Buildings & Structures*
 Application: *RPA-Roof Problem Areas*
 Substrate: *Carbon steel*
 Products: *Belzona 3121 (MR7), Belzona 9111 (Cleaner Degreaser)*

Customer Location: *Worksop*
 Application Date: *May 2019*

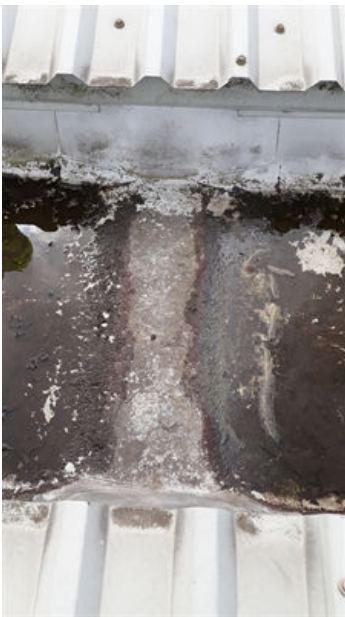
Areas of probable leaks were identified on external inspection of the high bay

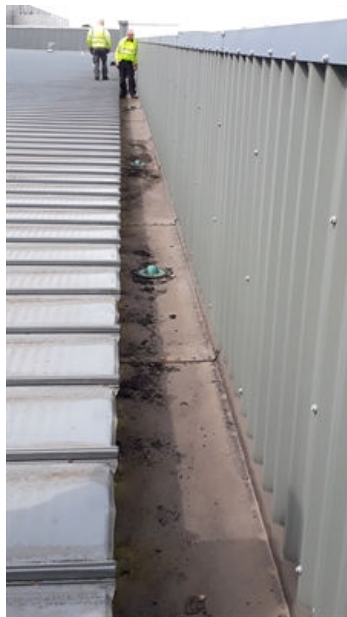
All joints were identified and marked on an aerial plan

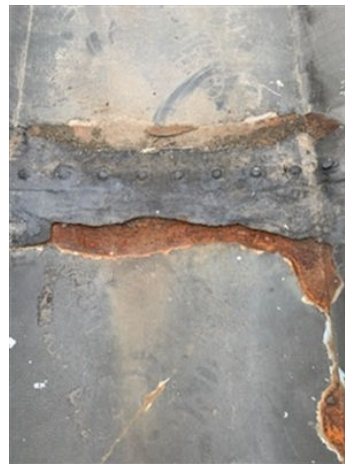
Obvious issues were showing and Belzona was the chosen solution

All old materials were removed

The area was wire brushed, cleaned and degreased using Belzona 9111

A first coat of Belzona 3121 was applied and the Belzona 9331 reinforcing sheet laid in

A second coat of Belzona 3121 was applied to complete the repair

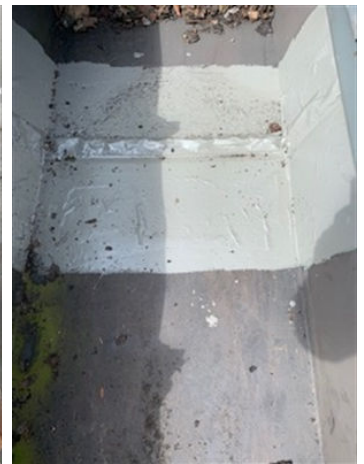
6 years on and the repairs to the valley gutter joints continue to protect.

6 years later, there have been no further issues with the Valley and side gutter joints
