BELZONA PROTECTS CITIES WATER PUMPS

ID: 996

Customer Location: City of Hannibal, MO

Application: CEP-Centrifugal Pumps

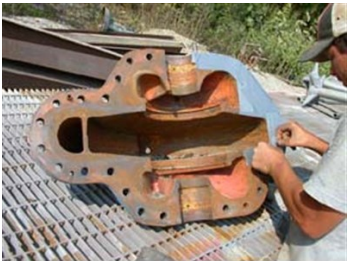
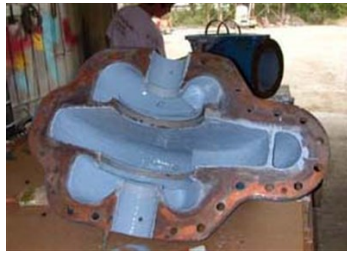
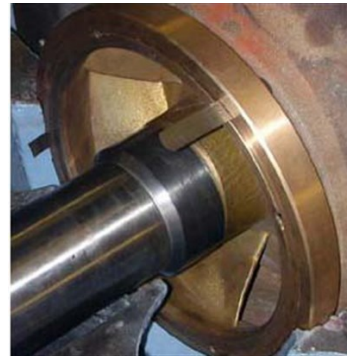
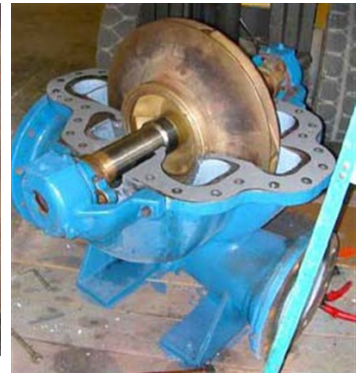
Photograph Descriptions

Failure due to high cavitation caused by bad suction conditions that could not be changed.

- * Lower casing half before application ,
- * Lower casing half, completed ,
- * Impeller with casing ring shimmed and ready to refit the casing ring seats ,
- * Rotor set in lower casing half, ready to install the top casing ,

Application carried out in accordance with Belzona Know-How System Leaflets CEP-3 and CEP-5.

Slightly over a days work and under \$2,000 of Belzona, the first pump was returned to service. A follow up was done in January 2008 and revealed this pump as well as others done subsequent to this one were still running like new.
