# BELZONA PROTECTS CITIES WATER PUMPS

Customer Location: City of Hannibal, MO

Application: CEP-Centrifugal Pumps

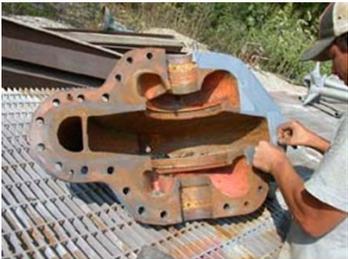
Failure due to high cavitation caused by bad suction conditions that could not be changed.

- \* Lower casing half before application ,
- \* Lower casing half, completed ,
- \* Impeller with casing ring shimmed and ready to refit the casing ring seats ,
- \* Rotor set in lower casing half, ready to install the top casing ,

Application carried out in accordance with Belzona Know-How System Leaflets CEP-3 and CEP-5.
