# Expansion Joint Repair

ID: 9965

Application: FPA-Floor Problem Areas

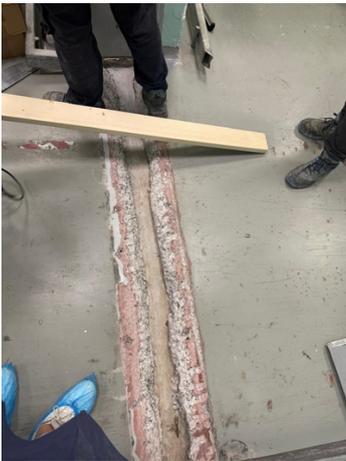
The expansion joint exhibited advanced deterioration, resulting in loss of movement accommodation and ineffective water sealing. This condition increased the risk of progressive substrate degradation and contributed to vehicle impact damage, including premature tire and suspension wear.

Initial surface condition

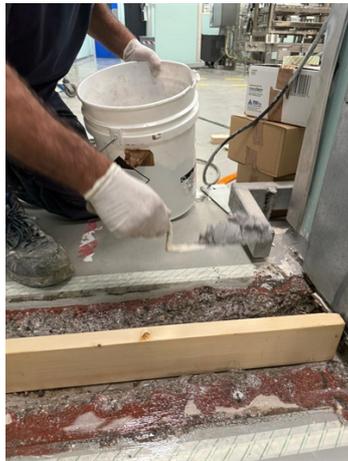
Belzona 4111 application

The application was carried out in accordance with FPA-5 and FPA-6.

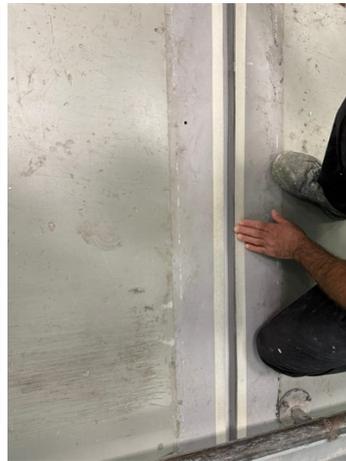
Belzona joint edge repair completed

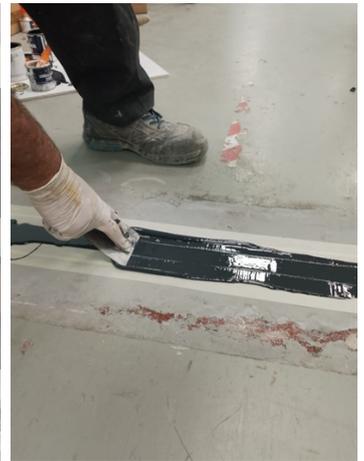
Application completed
