Pump Base Repair & Coating with Belzona

ID: 9974

Industry: Chemical & Petrochemical
 Application: TCC-Tanks and Chemical Containment Areas
 Substrate: Concrete
 Products: Belzona 4111 (Magma-Quartz), Belzona 5821

Customer Location: Decatur, AL
 Application Date: July 2025

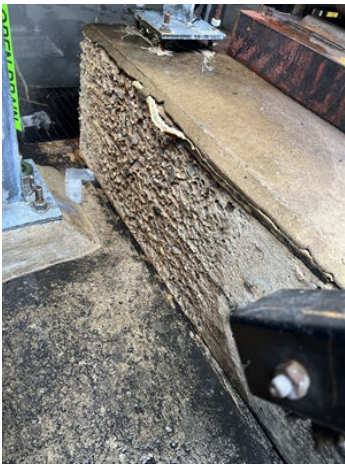
The concrete pump base had water running over it for several years due to constant water running over the pump to keep it from over heating. The water had been eroding the concrete for many years. They were facing the replacement of two pump bases.

Before Belzona concrete repair and coating picture

Damaged area on side of pump base.

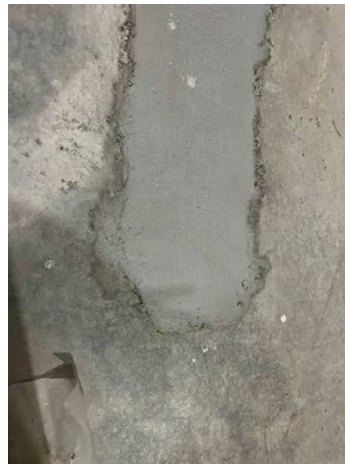
Repaired crack area on side of pump base using Belzona 4111

We used needle guns to prepare the surface area. Once the surface was prepared we then cleaned the concrete using a vacuum to remove dust and small debris and MEK to clean the surface.

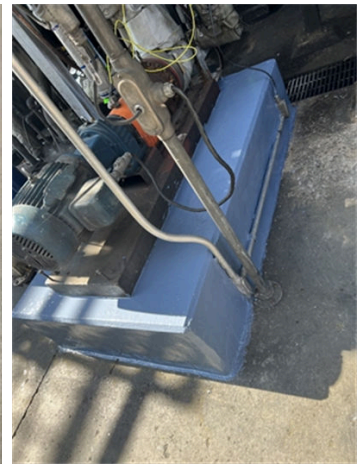
Completed repair and coating of concrete pump base using Belzona 4111 and Belzona 5821
