Fire Pump Casing Repair & Protection – IOL

Application: CEP-Centrifugal Pumps

Substrate: Carbon steel

Application Date: August 2025

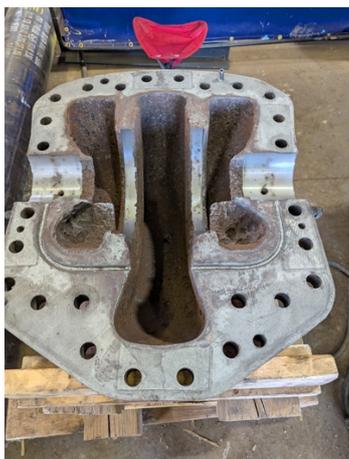
A critical fire pump casing at IOL was suffering from severe pitting and corrosion due to prolonged exposure to water. The deterioration risked further wall thinning, reduced efficiency, and potential leakage. Conventional repair methods (welding or replacement) would have been costly, time-consuming, and disruptive to plant operations.

The pump house before the application

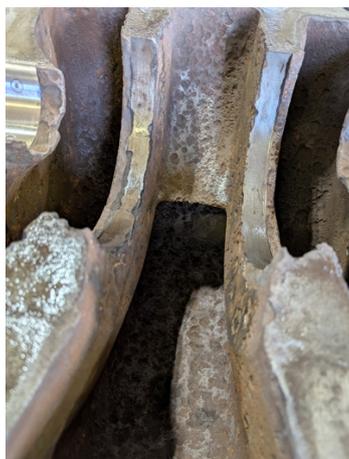
Severe pitting in the pump housing

The pump casing was grit-blasted to the SSPC-SP10 (Near White Metal) standard.

Achieved surface profile $\sim 75 \mu\text{m}$ (3 mils) for optimum adhesion. Area thoroughly cleaned and degreased with solvent.

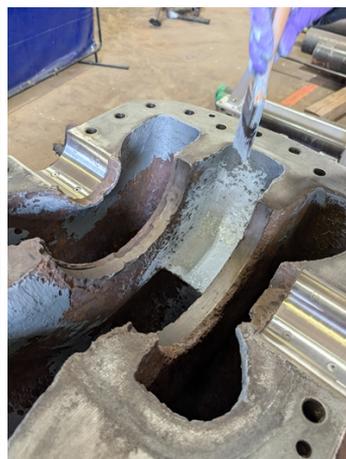
Rebuilding with Belzona 1121

Severely pitted and corroded areas were rebuilt using Belzona 1121 (Super XL-Metal). Applied by hand to restore original casing geometry.

Belzona 9411 was used as a release agent on tools and formers during application.

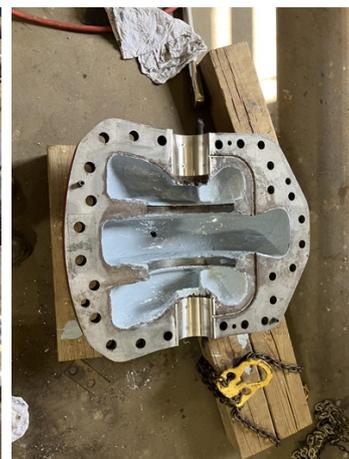
The pump house after the application of Belzona 1341

Once cured and prepared, two coats of Belzona 1341 (Supermetalgilde) were applied.

Provided long-term corrosion protection and efficiency improvement due to low-friction finish.
