Fire Pump Casing Repair & Protection – IOL

ID: 9980

Industry: Oil & Gas
Application: CEP-Centrifugal Pumps
Substrate: Carbon steel
Products: Belzona 1121 (Super XL-Metal), Belzona 1341 (Supermetalglide), Belzona 9411 (Release Agent)

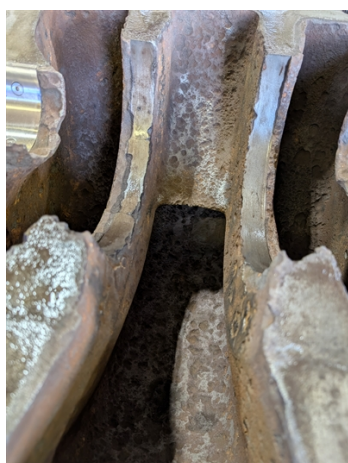
A critical fire pump casing at IOL was suffering from severe pitting and corrosion due to prolonged exposure to water. The deterioration risked further wall thinning, reduced efficiency, and potential leakage. Conventional repair methods (welding or replacement) would have been costly, time-consuming, and disruptive to plant operations.

Severe pitting in the pump housing

The pump casing was grit-blasted to the SSPC-SP10 (Near White Metal) standard.

Achieved surface profile $\sim 75 \mu\text{m}$ (3 mils) for optimum adhesion. Area thoroughly cleaned and degreased with solvent.

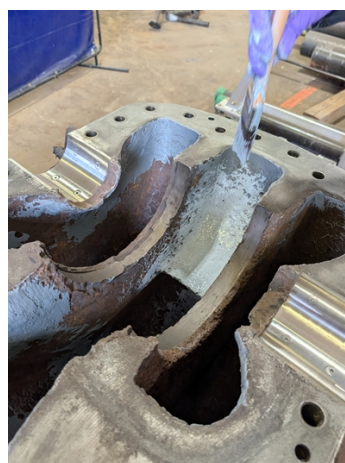
Rebuilding with Belzona 1121

Severely pitted and corroded areas were rebuilt using Belzona 1121 (Super XL-Metal). Applied by hand to restore original casing geometry.

Belzona 9411 was used as a release agent on tools and formers during application.
