Fiberglass Headers repaired and restored using Belzona 1813

ID: 9982

Industry: Oil & Gas
Application: TCC-Tanks and Chemical Containment Areas
Substrate: Other
Products: Belzona 1813

Customer Location: Beulah, North Dakota
Application Date: August 2021

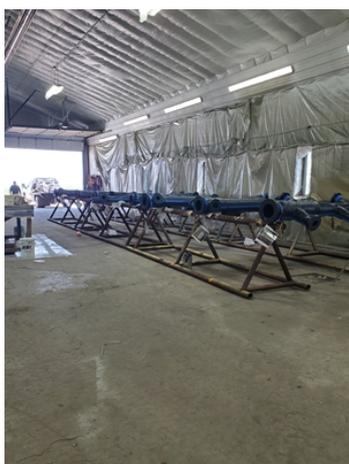
Fiberglass headers ready for manual preparation. These headers were taken off site and delivered to contractor's shop.

The fiberglass was manually prepped using grinders per Belzona spec and letter, cleaned using MEK cleaner and troweled on with Belzona 1813.

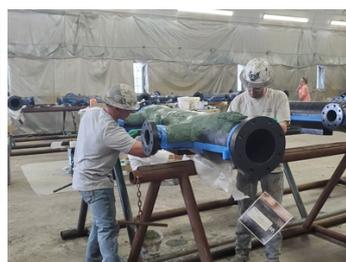
Contractor applying Belzona 1813.

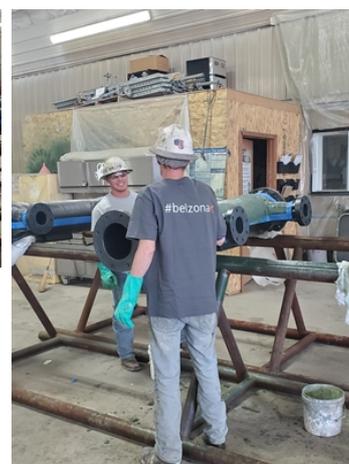
Belzona 1813 applied to fiberglass headers.

We did some small areas several years ago and the Belzona 1813 was actually lasting a lot longer than the Fiberglass Contractor using their own repair. They replaced 2 rows of headers and we manually prepped the fiberglass and put a layer on top of new headers before being installed. This is a great success for Basin Electric.
