Tank Base Sealing on Oil Storage Tank

ID: 9985

Customer Location: Kenova, WV
Application Date: June 2017

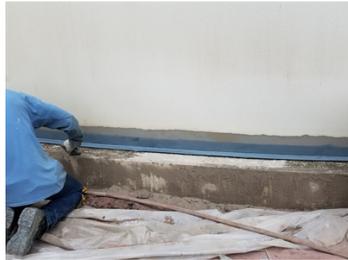
An example of the condition of the chime angle prior to any work starting.

The concrete pad and the steel tank were grit blasted, Belzona 3931 (WG Membrane Conditioner) was brush applied followed by two coats of Belzona 3131 (WG Membrane) which was also brush applied. Belzona 9351 (WG Reinforcing Sheet) was incorporated for added flexural strength.

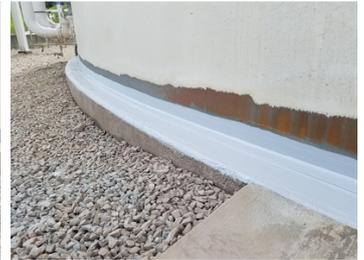
Belzona 3131 (WG Membrane) being brush applied with 9351 reinforcing sheet.
