Tank Base Sealing on Oil Storage Tank

ID: 9985

Industry:	Oil & Gas	Customer Location:	Kenova, WV
Application:	GSS-Gaskets, Seals and Shims	Application Date:	June 2017
Substrate:	Concrete		
Products:	Belzona 3131 (WG Membrane),Belzona 3931 (WG Membrane Conditioner)

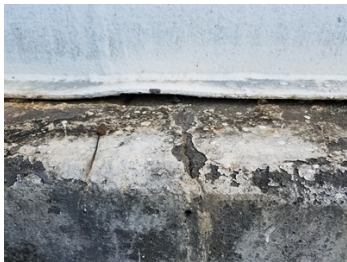
Corrosion develops under the floors of these tanks due to weather ingress. The floors are very expensive to replace.

An example of the condition of the chime angle prior to any work starting.

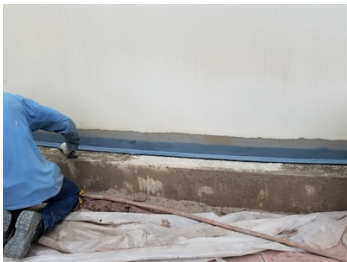
Belzona 3931 (WG Membrane Conditioner) being brush applied.

The concrete pad and the steel tank were grit blasted, Belzona 3931 (WG Membrane Conditioner) was brush applied followed by two coats of Belzona 3131 (WG Membrane) which was also brush applied. Belzona 9351 (WG Reinforcing Sheet) was incorporated for added flexural strength.

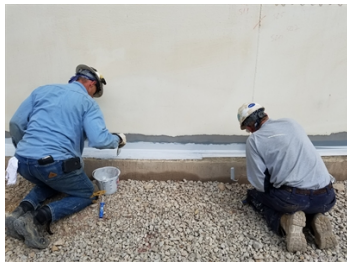
Belzona 3131 (WG Membrane) being brush applied with 9351 reinforcing sheet.

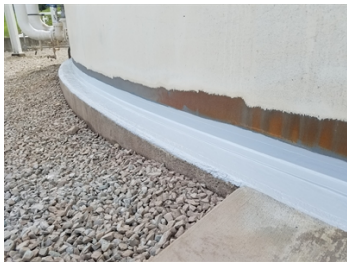
Finished application. Customer will go back with their tank paint to touch up areas that were grit blasted but not coated.

Sealing these tank chimes with Belzona prevents moisture from infiltrating the area under the tank floor, preserving the integrity of the floor for decades.
