# PUMP BELL MOUTH REBUILT AND PROTECTED WITH BELZONA

Application: CEP-Centrifugal Pumps

Customer Location: Power Station, Pakistan

Application Date: May, 2006

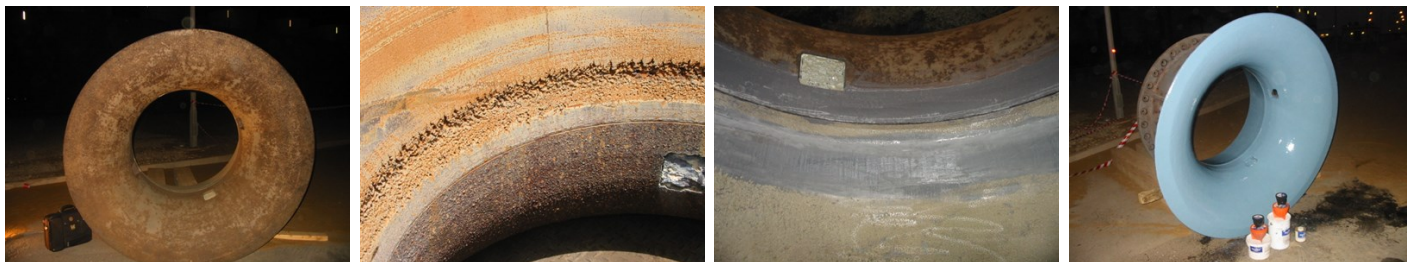
The pump bell mouth was badly eroded/corroded due to water quality.

\* Corroded Bell Mouth , \* Extent of the erosion apparent after grit blasting , \* Rebuilding with Belzona® 1311 , \* Completed job after applying Belzona® 1341 ,

Application was carried out in accordance with Belzona Know-How System Leaflets CEP-3 & -5.
