Revived Water Pump with Belzona

ID: 9990

Application: CEP-Centrifugal Pumps

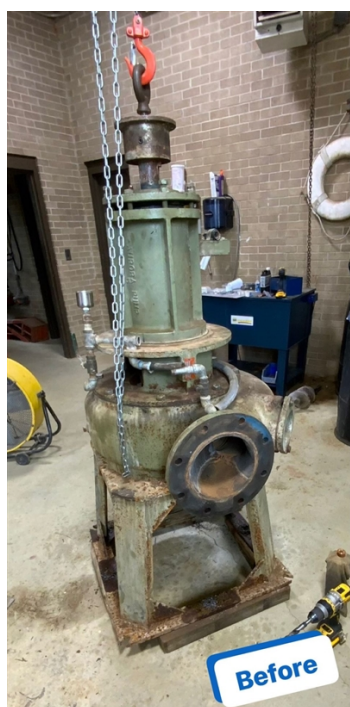
This pump is 30 plus years old and was in need of exterior restoration due to the environment it lives in.

Before Belzona restoration.

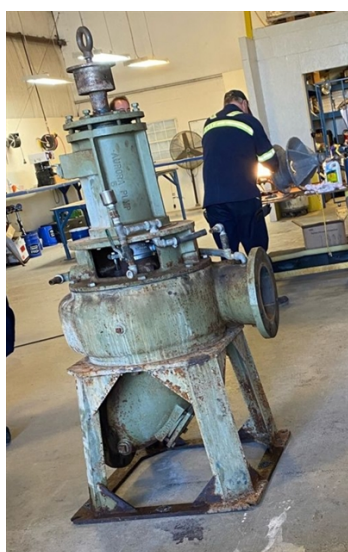
Preparing for blasting and cleaning

We blasted the surface area using a mild aggregate followed by properly cleaning the surface with an approved cleaner.

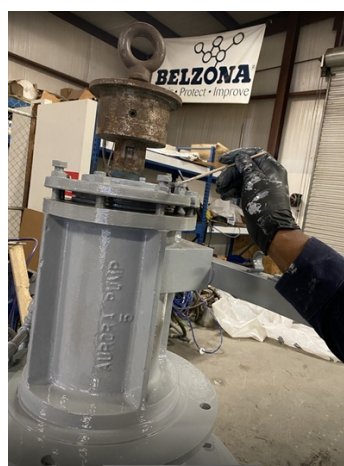
Final touch ups using Belzona 5811

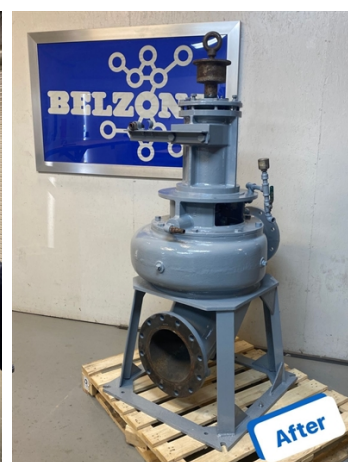
Finished results
