Belzona Flange Encapsulation System for Abu Dhabi Offshore Oilfields

Industry:	Oil & Gas	Customer Location:	Abu Dhabi
Application:	GSS-Gaskets, Seals and Shims	Application Date:	May 2020
Substrate:	Carbon steel		
Products:	Belzona 3412, Belzona 8411, Belzona 9111 (Cleaner Degreaser)

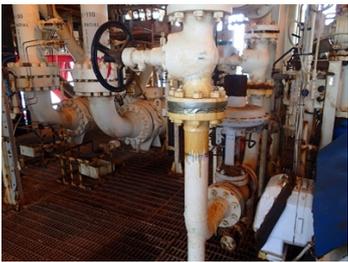
Client's maintenance crew carried out routine inspections in two oilfields off the coast of Abu Dhabi. The inspection revealed severe flanges corrosion which was a result of the aggressive operating environment.

Corroded flanges in the oilfields suffered corrosion attack and needed repair.

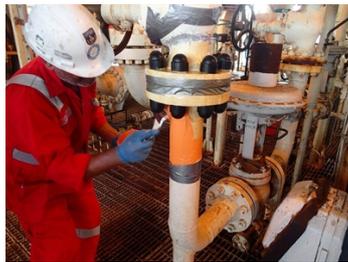
The technician applied the first coat of Belzona 3412 to protect the flange.

1. Remove the old paint from the top and bottom edges of the flange.
2. Brush away loose contaminants and degrease the surface using a rag soaked in Belzona 9111 (Cleaner Degreaser).
3. Roughen the top and bottom edges of the pipe with emery paper.

4. Apply masking tape to clearly define the coating area.
5. Apply Belzona 8411 to the flange and pipe area. Allow it to become touch dry. Belzona 8411 is required for the encapsulating membrane system in order to achieve the optimum level of corrosion protection and to allow access to bolts and flanges in the event of required maintenance.
6. Seal the gap between flange faces with bridging tape and cover bolt heads with plastic caps.
7. Mix Belzona 3412 and apply the first coat by brush at a thickness of 700–750 microns.
8. Wet out Belzona 9341 Reinforcement Tape with the mixed product to reinforce the flange and pipe edge. Allow the first coat to cure fully.
9. Once cured, apply a second coat of Belzona 3412 by brush at a thickness of 700–750 microns. Belzona 3412 is available in two colours and Belzona recommends different color for each coat.

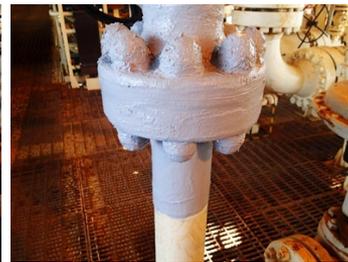
The second coat of Belzona 3412 was applied on the flanges and bolts.

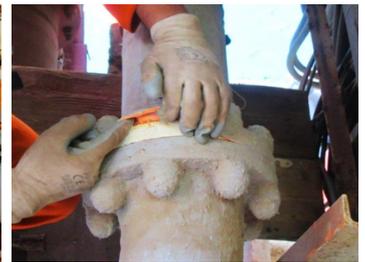
Six months after the application, the membrane was cut for an inspection and it was found that the flanges were in excellent condition.

Six months after the application, the Distributor has carried out an inspection and confirmed that the condition of the flanges was found to be excellent.

Belzona 3412 is an encapsulating membrane that can be cut and peeled for inspection during maintenance, then resealed for continued protection.
