Belzona repairs leaks in cooling towers and extends their lifespan

ID: 9995

Application: HEX-Heat Exchangers

Application Date: February 2025

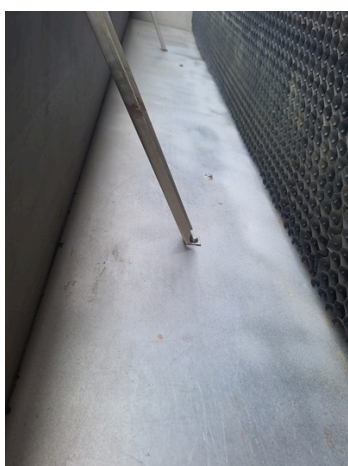
Surface preparation prior to Belzona systems being applied

1. Surface preparation: The cooling tower base and joints were cleaned and blasted to remove failed sealants, dirt, and contaminants.
2. Conditioning: Belzona 2911 (Elastomer QD Conditioner) was applied to ensure maximum adhesion.
3. Sealing: Joints were rebuilt and sealed using Belzona 2211 (MP Hi-Build Elastomer) and Belzona 2221 (MP Fluid Elastomer) for flexibility and resilience.
4. Protection: The base was over-coated with Belzona 5811 (Immersion Grade) to provide chemical and corrosion resistance in continuous immersion service.

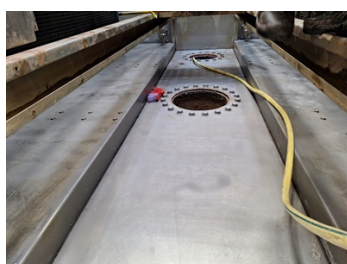
All the existing silicon's removed

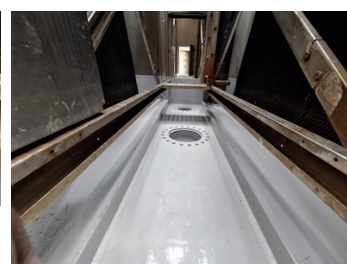
Application of Belzona 5811 (Immersion Grade) was carried out to enhance the protection of the cooling tower base
