# Methanol Column Skirt Repair

ID: 9997

**Industry:** Chemical & Petrochemical  
**Application:** TCC-Tanks and Chemical Containment Areas  
**Substrate:** Carbon steel  
**Products:** Belzona 1511 (Super HT-Metal), Belzona 1984, Belzona SuperWrap II, Belzona 5811 (Immersion Grade)

**Customer Location:** Scarborough, ON  
**Application Date:** September 2025

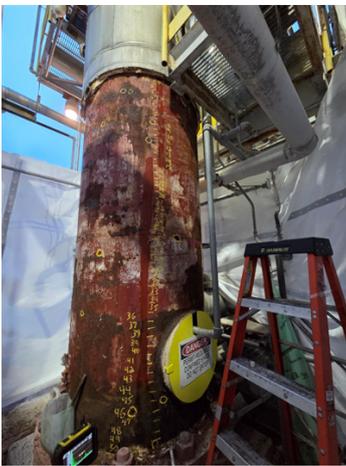
The bottom 30–35 inches showed extensive damage, including deeper pitting and metal loss.

Heavy pitting at the bottom of the skirt. Before the application of Belzona.

Deep pitted areas were rebuilt with Belzona 1511.  
Hand-applied and profiled flush with parent metal.

Applied using Belzona 1984 resin to bottom 30–35 inches. Applied in multiple wraps with reinforcing sheet for hoop strength.

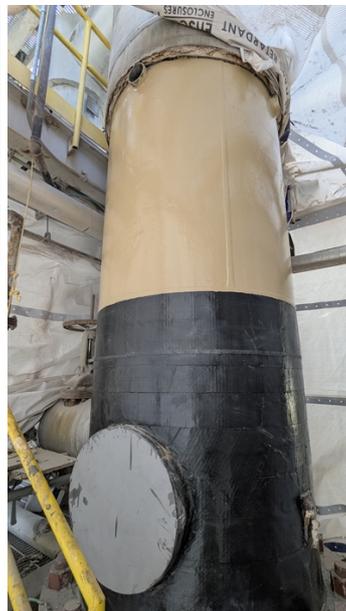
Closeup of worst defect in the column

We have successfully revitalized the structure, restoring its strength and beauty after the application of Belzona.

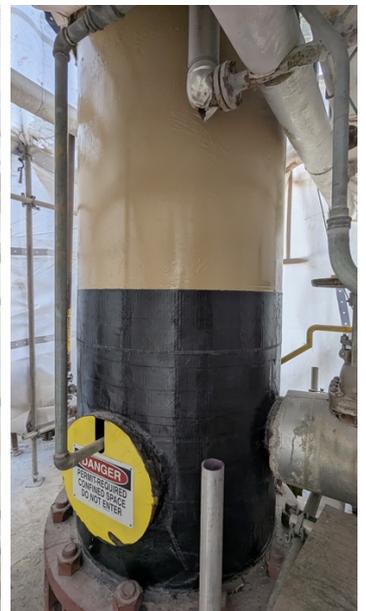
Another angle of completed repair

Remaining skirt area coated in two layers of 5811 for immersion-grade corrosion protection.
