REBUILDING TURBINE FLANGE FACES WITH BELZONA

CUSTOMER
Power station in Egypt

APPLICATION SITUATION
Low pressure steam turbine

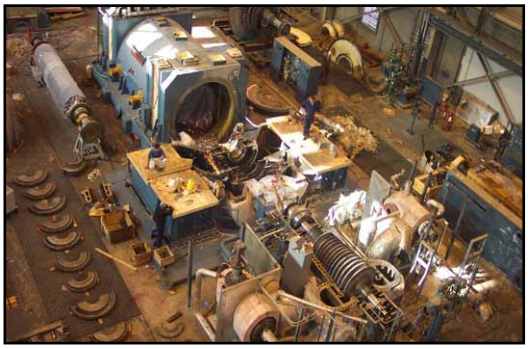
PROBLEM
Corrosion and steam cutting on many areas of flange faces.

PICTURES
1. General view of the turbine
2. Typical damage found on the flanges
3. Former clamped in place to form the Belzona® 1311
4. One of the many repaired areas

APPLICATION METHOD
Application was carried out in accordance with Belzona Know-How System Leaflet ENC-7.

BELZONA FACTS
Formers were cut from MDF (Medium Density Fiber Board) to match the repair areas on the various flange areas. Belzona is a proven effective long term repair for this type of damage.
