Vol.XXVIII No.50

# BELZONA REBUILDS AND PROTECTS SEAWATER STRAINER

## CUSTOMER
Dry Dock Facility, Newfoundland, Canada

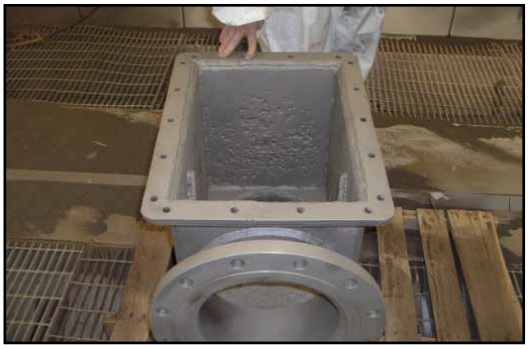
## PROBLEM
Erosion corrosion was taking its toll on the inner surfaces of this seawater strainer. Years of inadequate protection from inferior coatings was dramatically reducing the span of this important piece of equipment.

## PICTURES
1. The extent of the corrosion damage can be seen after the seawater strainer has been grit blasted
2. The pitted areas were rebuilt with Belzona 1311
3. The completed repair after the application of 2 coats of Belzona 1321

## APPLICATION METHOD
Application was carried out in accordance with the modified Belzona System Leaflets SOS-1 & -2.
