Vol.XXXI No.105

BELZONA REBUILT DAMAGE BOW OF RECREATION BOAT

CUSTOMER
BC, Canada

APPLICATION DATE
July 2004

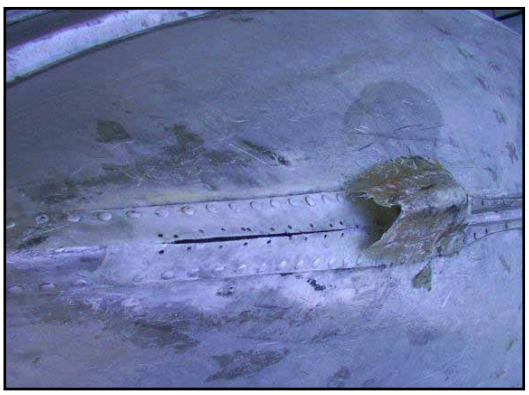
PROBLEM
The rivets on the bow that hold the two halves of the aluminum boat shell together would get worn out from the successive beachings.

PICTURES
1. Condition of vessel bow showing failed fiber glass repair.
2. Bow rebuilt to shape with Belzona 1311.
3. Entire repair further protected with 2 coats of Belzona 1321.
