BELZONA REFURBISHED LOADING DOCK STILL GOOD 7 YEARS ON

CUSTOMER
Business complex, Brisbane, Queensland, Australia

APPLICATION DATE
May 2009

APPLICATION SITUATION
Loading dock and car park of a multi use business complex.

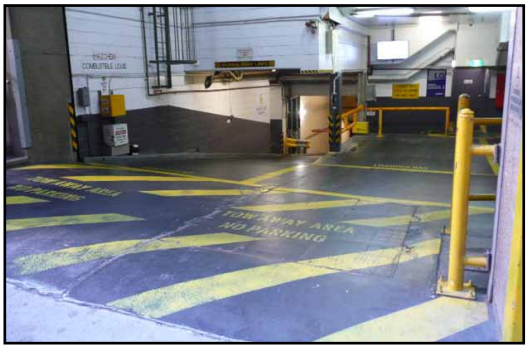
PICTURES
1. The original condition of the floor area
2. Surface preparation in progress
3. The finished application showing the coated floor and reinstated lines, wording and chevrons
4. The floor after 7 years in service

APPLICATION METHOD
The application was carried out in accordance with Belzona System Leaflets FPA-4 and FPA-8. The floor area was prepared using a dustless diamond grinder then coated with 2 coats of Belzona 5231. The line markings, chevrons and wording were then reinstated using Belzona 4411 in a single coat of safety yellow.
