Vol.XXXIV No.63

BELZONA RESURFACES LAB TABLES

CUSTOMER
Atlanta, GA, USA

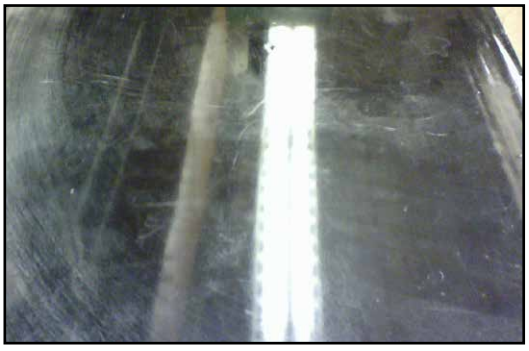
PROBLEM
At Georgia Tech, customer wanted to provide a durable surface without having to replace soapstone tables of 40 years of wear and tear have degraded tables.

PICTURES
1. View of original table
2. Application of first coat
3. Completed application
4. After 5 years, another lab top table was being repaired. Lab was being rebuilt, but the tops were remained

APPLICATION METHOD
Sanding tables to provide a good profile. Then applied two coats of Belzona 5811.
