BELZONA REPAIRS ARMY VEHICLE

ID: 2452

Customer Location: *British Army, UK*
Application Date: *2010*

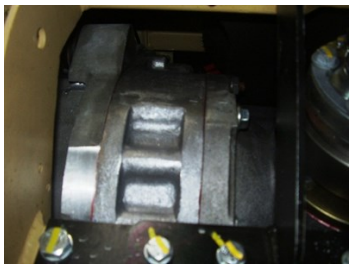
The vehicle's gearbox casting was porous leading to unacceptable oil loss.

* The Jackal ,
* The porous gearbox casting before application ,
* The gearbox sealed with Belzona® 1161 ,

The Belzona repair was completed without heat and without removing the gearbox. Belzona® 1161 surface tolerant properties makes it ideal for this type of repair where oil contamination may be difficult to completely remove.
