BELZONA MAINTAINS POWER PLANT MAIN COOLING WATER SYSTEM

ID: 4385

Customer Location: *Nuclear Power plant, France*
Application Date: *July 2012*

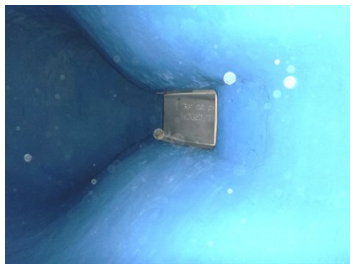
The continuous flow of water through the system had caused the concrete construction to wear both upstream and downstream of the pump, as well as inside the pump volute. This erosive wear had led to micro cracking of the concrete. In addition the rough concrete surface had led to a loss of efficiency as the worn concrete walls created a more turbulent flow.

* Volute prior to application ,
* Application of Belzona® 4111 completed ,
* Application of Belzona® 1341 ,
* View of the volute following repair ,

The application was carried out in accordance with Belzona Know-How System Leaflet CEP-10. The upper 15 linear metres were protected using Belzona® 5811. The severely eroded section where pipe turned 90° was restored using Belzona® 4111 across an

area of approximately 20m². The area was then over-coated with Belzona® 1341 to create smooth surface with optimum efficiency. Another 20m² section, right underneath the pump, was also repaired and protected in the same way. Finally, the pump outlet was also restored over an area of 130m² using the same system.
