# BELZONA TECHNOLOGY REPAIRS SHAFT

Industry: *General Industry*
Application: *MPT-Mechanical Power Transmission*

Customer Location: *Toronto, ON, Canada*
Application Date: *July 2015*

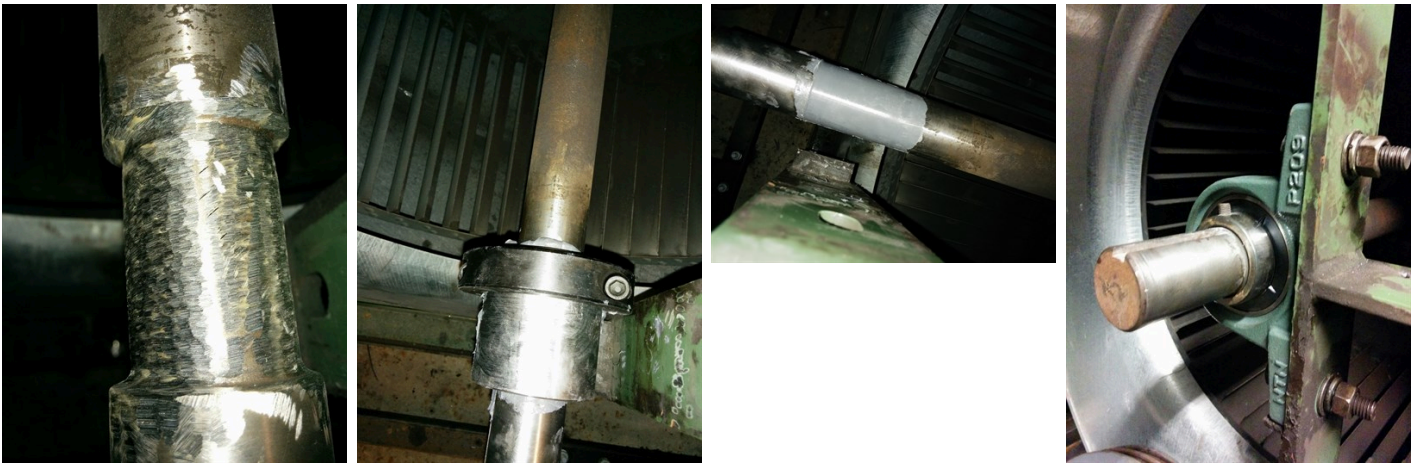
Poor lubrication and wear to the bearing caused it to gouge out material from the pulley shaft.

* Preparation complete ,
* Application in progress ,
* Completed application ,
* Shaft back in service ,

The application was carried out in accordance with Belzona Know-How System Leaflet MPT-2 for rebuilding damaged shafts using forming techniques. The area was prepared for application using a grinder to roughen the surface. Belzona 9411 was applied to the former in accordance with appropriate Belzona Instructions For Use. Belzona 1212 was applied onto the shaft and former, then the

former was attached to the shaft, allowing Belzona 1212 to cure. Once Belzona 1212 cured, the former was removed and the application was completed by removing trim lines and excess material.
