BELZONA SUCESSFULLY RENOVATES PUDDLE PIPES

ID: 947

Customer Location: *Nuclear Power Station, UK*
Application Date: *Summer 2006*

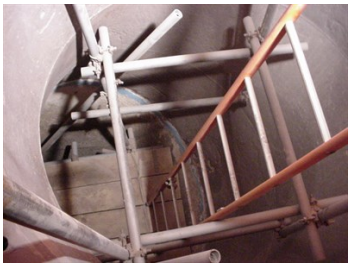
Corrosion affects these pipes where the concrete pipe in the sea connects with the steel pipe into the power station and the previous ceramic based products had failed to give the level of protection that was needed. Very regular coating was needed to keep the situation under control.

Corrosion on seawater inlet pipe to cooling system for nuclear power station.

Application carried out in accordance with Belzona System Leaflets VPF-1 and VPF-2. A 4-coat system was adopted by the power station to maximise longevity.
