BELZONA REPAIRS HYDRAULIC TANK

ID: 5412

Industry:	*Mining & Quarrying*	Customer Location:	*Covington, VA, USA*
Application:	*TCC-Tanks and Chemical Containment Areas*	Application Date:	*August 2014*
Substrate:	*Steel*		
Products:	** Belzona 1111 (Super Metal) ,*

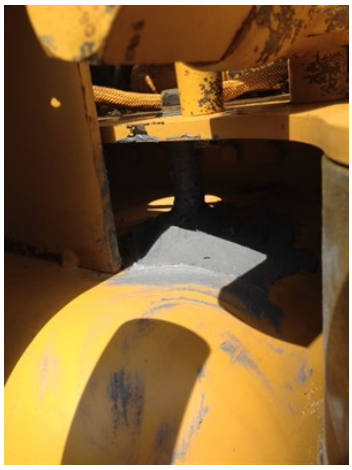
Mounting bolt on the hydraulic tank of a front loader came loose and was leaking.

* Overview of the mounting bolt and stud ,
* Close up of the problem area ,
* Repair completed ,

Leaking and loose mounting bolt on front loader's hydraulic tank.

The grating around the tank was removed. The area around the mounting stud was then ground and roughened. A detergent was then used to clean the surface, followed by a suitable cleaner/degreaser to remove contaminants such as oil, dirt and grease. Belzona 1111 was then mixed and applied, building up the area around the mounting stud.

The Belzona repair to the hydraulic tank saved a great amount of downtime and man hours. Replacement would take the company a day to remove the tank and take it apart. An additional day would be needed to clean, weld and re-assemble. The repair with Belzona took about a half hour, with an additional couple of hours to allow to cure. The front loader was returned to service the following day, since the application was carried out late afternoon. It has been in operation since the repair, with no leaks.
