BELZONA ENSURES SAFETY AT A UNIVERSITY

Industry: *Buildings & Structures*
Application: *FPA-Floor Problem Areas*
Substrate: *Steel*
Products:
* Belzona 1821 (Fluid Metal) ,
* Belzona 4411 (Granogrip) ,

Customer Location: *University, Manchester, England, UK*
Application Date: *2015*

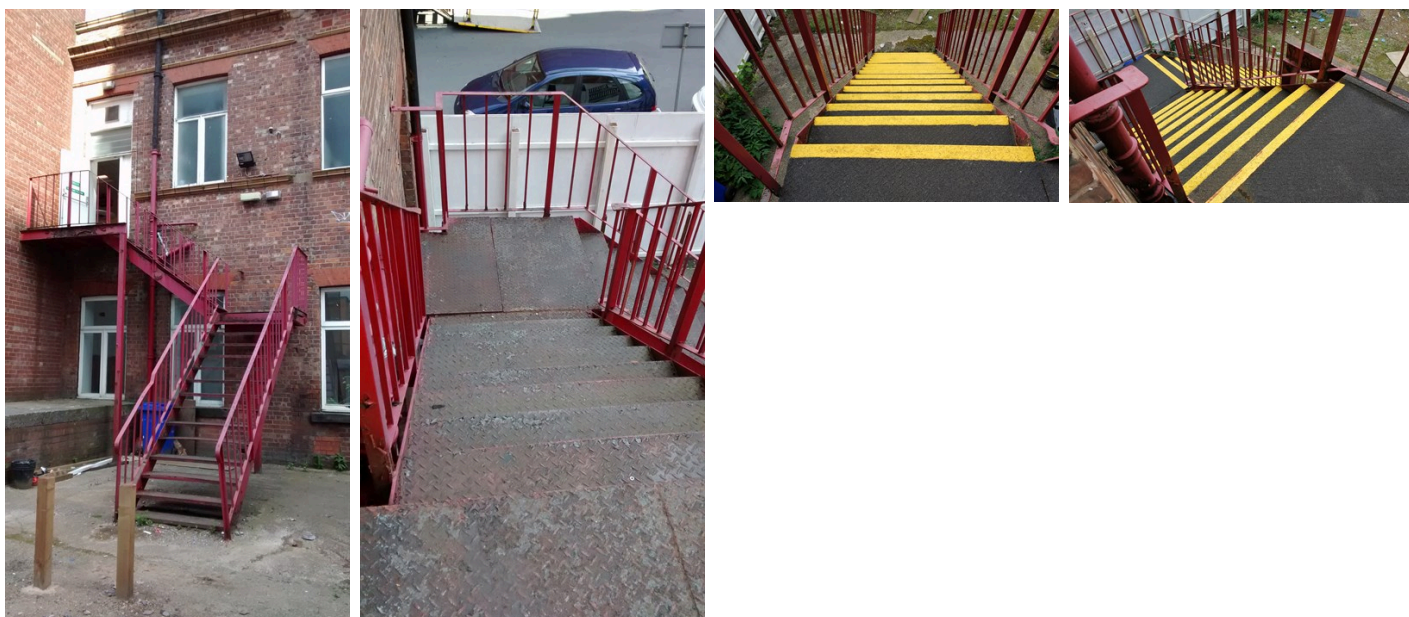
During a fire drill it was discovered that the steel chequer floor was slippery. This presented a real danger particularly in a real emergency. Left unresolved there could have been disastrous consequences.

* 1. Overview of the fire escape before application ,
* 2. Close up of the steel chequer plate ,
* 3. Close up of completed application ,
* 4. Overview of completed application ,

The Customer was seeking a fast and effective long term solution that could be met within the budget constraints and with minimum disruption to the University. The whole floor surface was coated with Belzona 1821 and the surface blinded out with Belzona 9221. The exception being the nosings which were coated in Belzona 4411 yellow to highlight them in line with current safety legislation, Belzona 9221 was sprinkled on these areas to create sufficient grip. The application was a complete success providing safety to those using the fire escape and ensuring long term protection to the floor surface.
