BELZONA REPAIR TO LARGE EXCAVATOR CONTROL CABLE

Ferro-nickel plant in Macedonia

Control cable from large iron ore excavator.

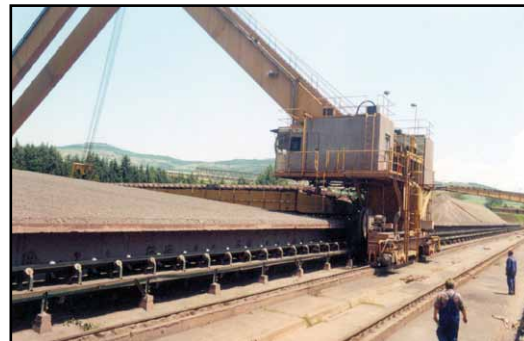
1. View of excavator.
2. Torn cable cover.
3. Repaired cable with Belzona® 2311.
4. Condition after 14 months in service.
