RUBBER TRACKS ON MOBILE DRILLING RIG QUICKLY REPAIRED WITH BELZONA

Geotechnical survey company, Croatia

September, 2013.

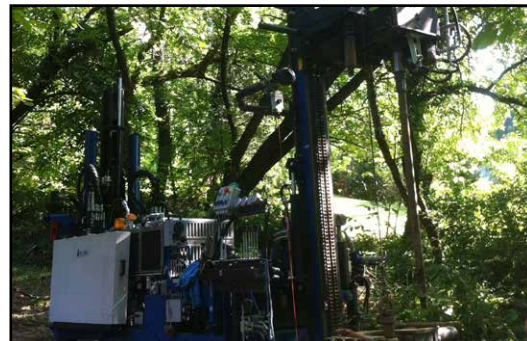
1. Geo drilling machine on site
2. One of the damaged areas on the tracks
3. Damaged area after surface preparation and Conditioning
4. Application finished.
