BELZONA REPAIRS PROFILE OF HYDROELECTRIC DAM

Rebuilding the profile of a small hydroelectric dam.

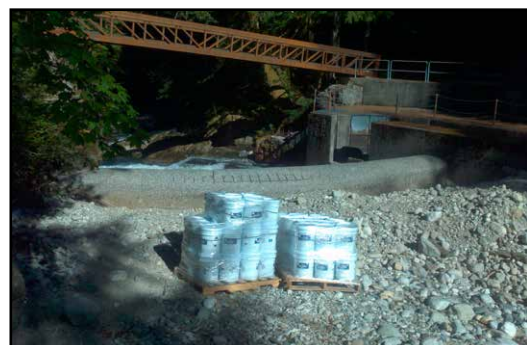
1. Dam (ogee) profile before repairs
2. Several pallets of Belzona 4111 on site
3. Dam repairs underway - note templates & mixer
4. Completed application

With the help of plywood templates, the dam profile was rebuilt with Belzona 4111 applied by hand. The application time was limited due to possible mountain runoff. Work was tightly monitored and contained so as not to pollute nearby fish spawning grounds.
