BELZONA REPAIRED DAMAGED MIXER AGITATOR DRIVESHAFT AND KEYWAYS

Mixer agitator driveshaft and keyways

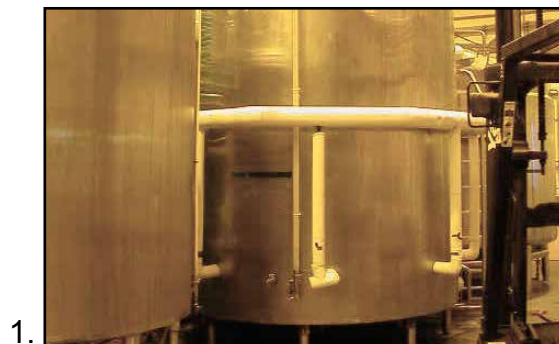
Acid damaged shaft lost 1/2" on the diameter, keyway and key were destroyed. Socket keyway was minimally damaged, but needed to be tightened up. Obsolete drive was built in 1965 and the MFG has been sold twice. Therefore, no parts or prints are available. Mixer shut down. It was imperative that it would be operated in only two days.

1. Mixing tank
2. Damaged drive shaft
3. Agitator socket
4. Ready for assembly

The application was carried accordance to the modified version of Belzona Know-How leaflet system MPT-2. Belzona 1111 was used to build up the shaft diameter and also applied inside the socket and around the new key to fill the keyways. While still wet, the shaft was carefully dropped into the agitator socket keeping the key tight in both keyways.
