## MINE LOCOMOTIVE AXLE REPAIR

Brown coal Mine plant, Slovakia

2005

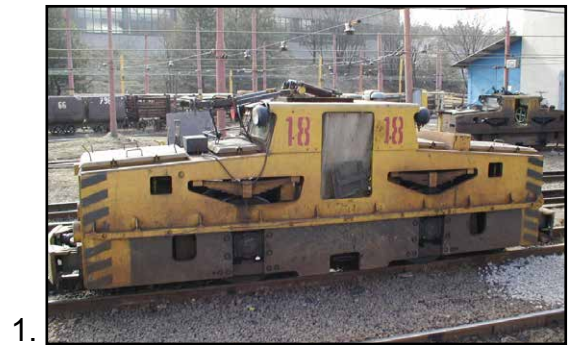
Slide assembly wear of the shaft axle caused by a bronze bearing and causing a high level of noise.

1. Mine locomotive
2. Failed bearing
3. Repair in progress
4. Renovated axle

Application was carried out in accordance with Belzona Know-How System Leaflet MPT-1. Shaft was turned down and left with coarse thread before being rebuilt with Belzona 1311 followed by machining back to original diameter.
