Mine locomotive axle repair

ID: 2457

Customer Location: *Brown coal Mine plant, Slovakia*
Application Date: *2005*

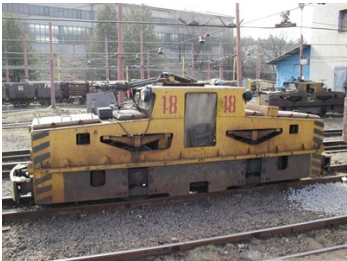
- * 1. Mine locomotive ,
- * 2. Failure bearing ,
- * 3. Repair in progress ,
- * 4. Renovated axle ,

Due the slide assembly wear of shaft axle in bronze bearing the shaft unloading appeared. Direct mark of this failure is big noise level.

Application was carried out in accordance with Belzona Know-How System Leaflet MPT-1. Shaft was turned down and left with coarse thread before being rebuilt with Belzona 1311 followed by machining back to original diameter.
