# REPAIR OF MOTOR BLOCK OF 789 MINING TRUCK

ID: 4868

Customer Location: Mine, Chile  
Application Date: January 2005

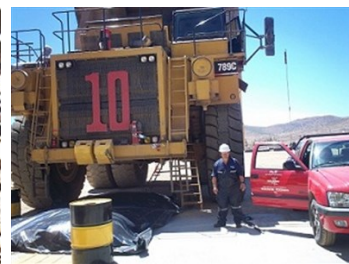
The engine was corroded and presented a problem in the filtration area where water flows from the engine block

- \* Damaged engine block ,
- \* Application of Belzona 1111 ,
- \* Engine block repaired with Belzona 1111 ,
- \* Repaired mining truck 789 ,

The damaged area was cleaned, and heat was applied to eliminate oil residue. Next, the area was roughened with sand paper and Belzona 1111 was applied to the prepared surface.
