BELZONA REPAIRS PROFILE OF HYDROELECTRIC DAM

ID: 5285

Customer Location: Washington, USA
Application Date: October 2012

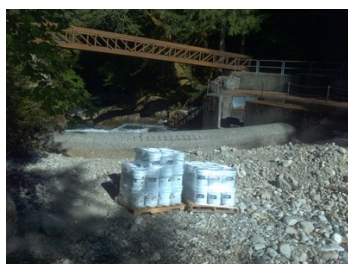
The profile of a small hydroelectric dam became worn, exposing reinforcing bar, which was caused by damage from VW sized boulders tumbling into and over the face of dam during spring runoff. The client was concerned about maintaining the integrity of the small hydroelectric dam and restoring the original profile.

- * Dam (ogee) profile before repairs ,
- * Several pallets of Belzona 4111 on site ,
- * Dam repairs underway - note templates & mixer ,
- * Completed application ,

With the help of plywood templates, the dam profile was rebuilt with Belzona 4111 applied by hand. The application time was limited due to possible mountain runoff. Work was tightly monitored and contained so as not to pollute nearby fish spawning grounds.
