Belzona Know-How

FOR REPAIRING LEAKING PIPEWORK

HEX-9

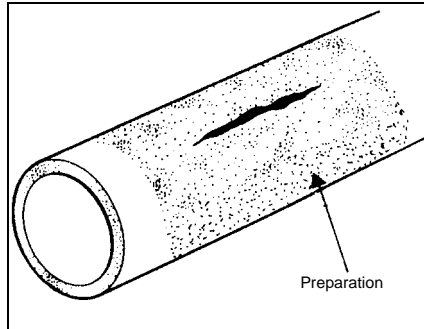
Fig. 1

mechanical tools. As a general rule, the less effective the preparation the larger the prepared area should be, thus extending the bond area in order to compensate for lack of prepared surface profile (fig. 1).

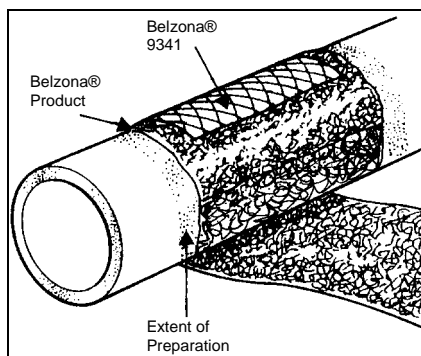
Fig. 2

Apply a thin layer of Belzona® material to all prepared areas pushing it well into the prepared profile. Wet out a length of **Belzona® 9341** with mixed Belzona® material. The length of the **Belzona® 9341** must be at least twice the pipe circumference. Apply the tape, coated side down, to the repair and wrap firmly around the pipe until the Belzona® product is forced through to the outer surface (fig. 2). Apply a further layer of Belzona® product to completely seal the surface (fig. 3).

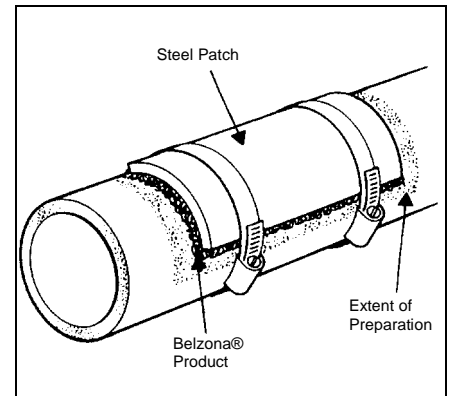
Fig. 4

Apply a thin layer of Belzona® material to all prepared areas including the preformed patch, forming a peak towards the center.

Push the patch into position ensuring minimal air entrapment. Remove excess material immediately (fig. 4).
