BELZONA SLOWS ABRASION TO A CRAWL

Blast pot used in the customers pneumatic conveyor system was being worn through.

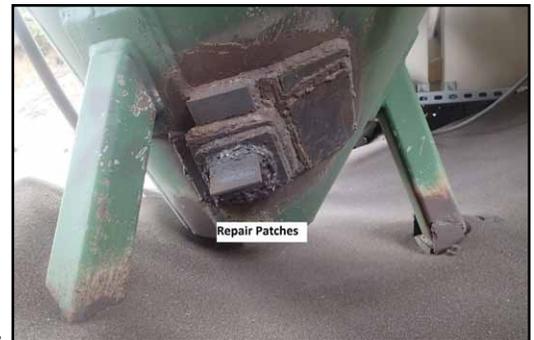
Customer uses pneumatic conveying system to move sand throughout their large facility, this blast pot was being repaired constantly as pressurized air combined with the sand in system to abrade holes in the pot opposite port into which air was injected. New equipment was only lasting a few weeks before needing to be patched and after than needed constant repair.

1. Blast pot with patch on top of patch, the previous solution
2. Impact area inside pot prepped for application
3. Application of Belzona 1812 in progress
4. Application Complete
