BELZONA PROVIDES COST EFFECTIVE MAINTENANCE OF OIL CENTRIFUGES

Centrifuges used to separate fine sand particles from oil production

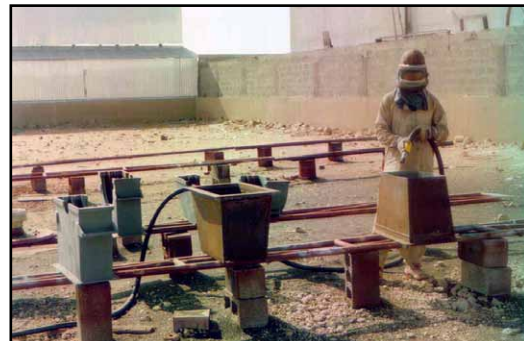
1. Centrifuge components being grit blasted.
2. Some of the components after coating with Belzona® 1321.
3. The scroll from a centrifuge.
