## BELZONA PROTECTION TO FOAM GLASS INSULATION ON TANK

Chemical Plant in Louisiana

Foam glass insulation on roof of 70' diameter tank

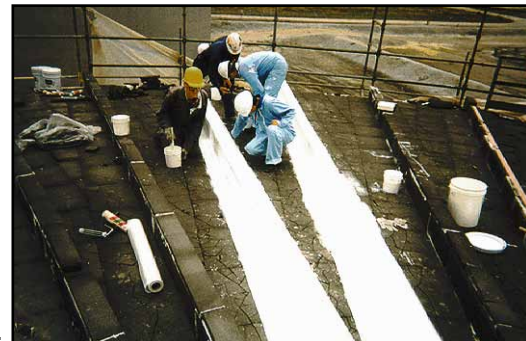
1. Application begins to the foam glass insulation.
2. Work in progress.
3. The finished application. Seamless encapsulation and waterproof protection to the insulation with Belzona® 3211.
