BELZONA PROTECTS PAPER MACHINE STRUCTURAL STEEL

Pulp and Paper Company in West Virginia, U.S.A.

Spring 1997

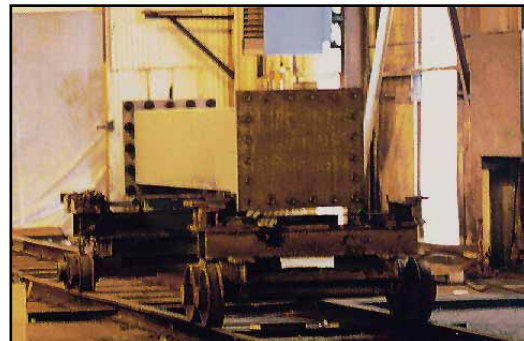
1. Following surface preparation by grit blasting, columns and beams were moved by rail to an environmentally-controlled application area.
2. Belzona® 5811 brushed and eventually troweled to a smooth finish.
3. All beams, columns and plates coated with Belzona® 5811. They were then pre-assembled at fabrication warehouse to check tolerances.
