BELZONA SLIDES THE CHIPS OFF THE BARK SHAKER

Pulp Mill in Alabama, U.S.A.

Bark shaker sorts and distributes bark to the boiler.

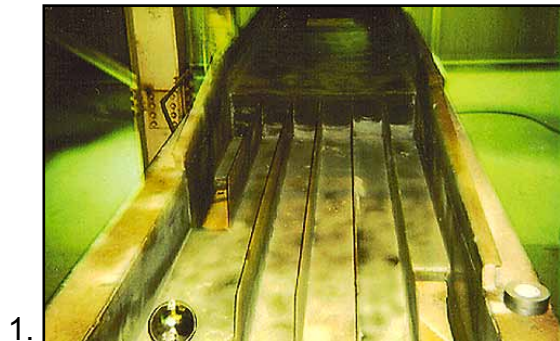
1. The bark shaker.
2. Belzona® 1341 provides a slick surface and the bark slides off.
3. Another view of the 30 foot long, 8 foot wide bark shaker coated with two coats of Belzona® 1341.
