## BELZONA PROTECTS NEW CHEMICAL CONTAINMENT AREAS AT REFINERY

International Oil Company

Building of a totally new oil refinery was being completed. Chemicals being handled include 98% sulphuric acid and 36% hydrochloric acid.

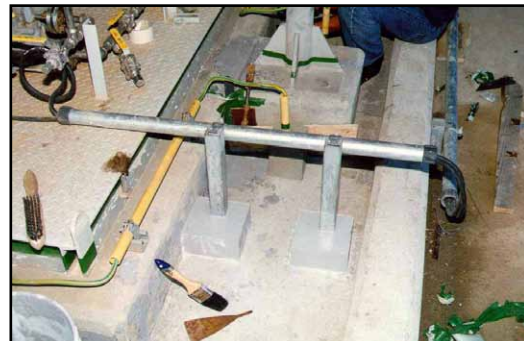
1. Electrical and pipe supports were grouted into place using Belzona® 4111 system
2. Application of Belzona® 4311 underway
3. & 4. Views of some of the many completed areas
