BELZONA® 3211 PROTECTS LPG SPHERES

Pressurized storage spheres for Liquefied Petroleum Gas (LPG)

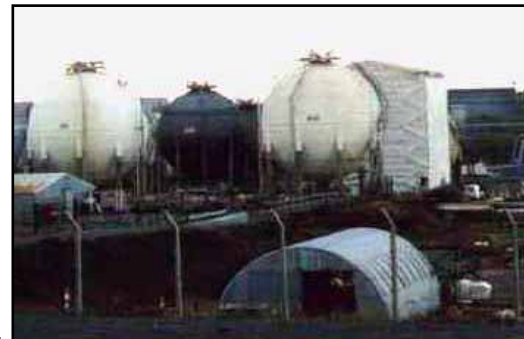
1. Work underway on one of the spheres within the environmental screen
2. Close up of the application showing complete sealing around pipework
3. A completed sphere

The insulation was re-installed using a closed cell foam glass that is impervious to water and Belzona® 3211 applied in accordance with Belzona® Know-How System Leaflet TCC-4.
