## BELZONA PROTECTS CHIP CYCLONE WELD SEAMS

Pulp & Paper Mill in North Carolina, U.S.A.

September 1991

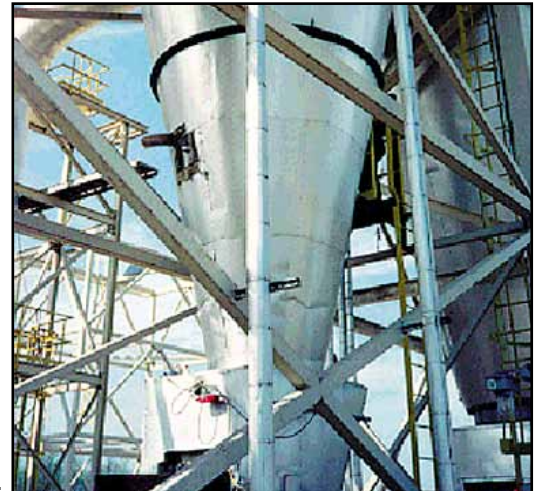
Chip cyclone used to remove oversized chips, pin chips, fines, bark, burnt wood, rotten wood, dirt and foreign materials.

1. Conical shaped chip cyclone.
2. Eroded weld seams of the chip cyclone.
3. Belzona® 1321 being used to protect weld seams from future erosion.

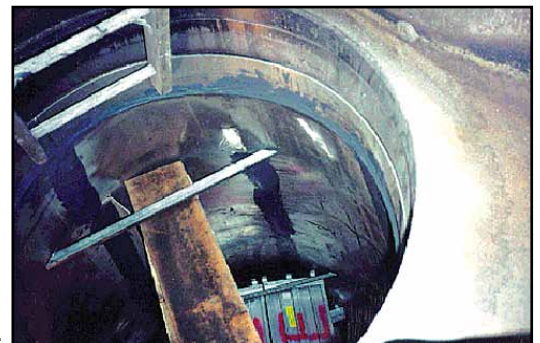
The chip cyclone suffers from continuous erosion, and the irregularities and/or protrusions of the weld seams were attacked.
