## BELZONA PROVIDES PROTECTION FOR FOREPEAK HOLDING TANK

A 110' island class patrol boat - Matagorda.

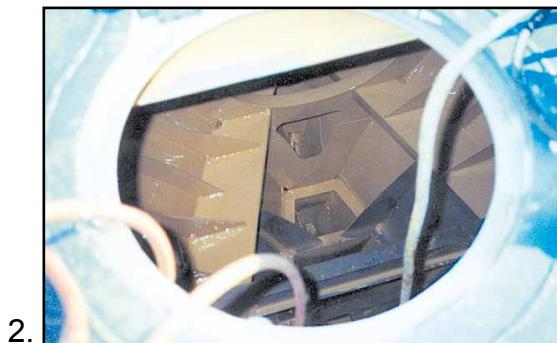
Rust in the forepeak holding tank.

1. The Matagorda.
2. Looking below, stripe coating in progress.
3. Finished view of forepeak.

Belzona® 5811 (Immersion Grade)

The application was carried out in accordance with Belzona Know-How System Leaflet TCC-5.
