## BELZONA SPECIFIED FOR OEM EQUIPMENT AT WASTEWATER TREATMENT FACILITY

Wastewater Treatment Facility - British Columbia, Canada

Application of Belzona® 1321 to OEM venturi pipe. This equipment is part of the aeration process.

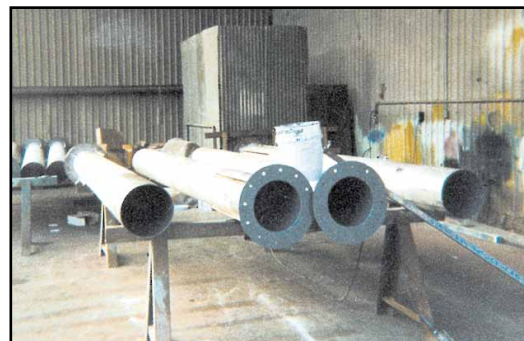
1. Coating internal surface and flange face of 18 main pipe stands (14 ft in length) in progress.
2. Coating of both internal and external surfaces of 8 ft venturi pipes.
3. Completed application showing three of the assembled units.
