BELZONA BONDS MOBILE ANTENNAE TO WATER TOWER

Municipal water district and contractor to mobile telephone service providers in Washington, U.S.A.

Water storage tank

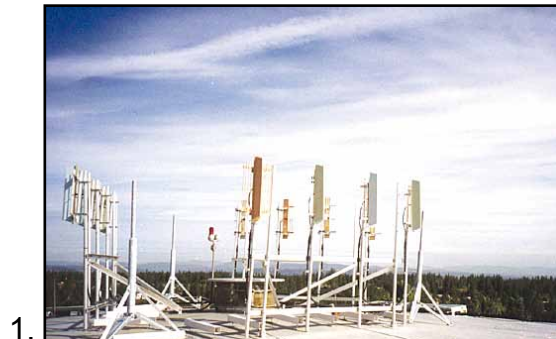
1. Antennas mounted atop the tank.
2. Close-up of bonded pad for support.
3. The finished job.

The application was carried in accordance with a modified version of Belzona Know-How System Leaflet TCC-3 and GSS-9.
