BELZONA PROTECTION OF OIL SKIMMER DISCHARGE PIPE

Oil Refinery-Australia

May 2004

Concrete pipe discharging the clean water from the oil skimmer into the sea.

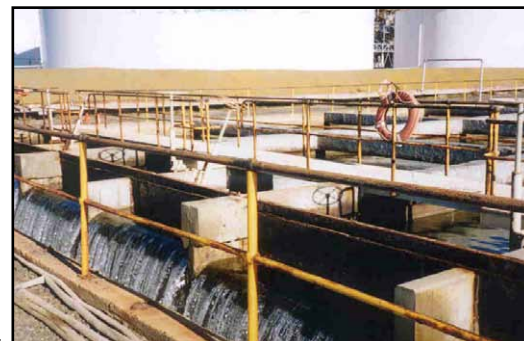
1. General view of the Oil Skimmer.
2. Belzona® 4211 being used to seal leaks.
3. Joints smoothed out with Belzona® 1111 prior to coating.
4. Completed application with Belzona® 5811 applied to entire surface of the pipeline.

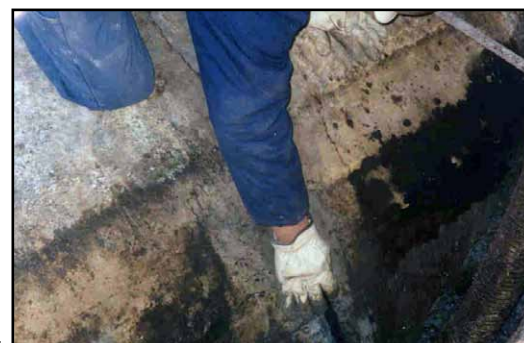
2.

Joints were leaking and external protection of the concrete required.

Application was carried out in accordance with Belzona Know-How System Leaflet VPF-11b. After sealing leaks with Belzona® 4211, Belzona® 1111 used to smooth out joints, then Belzona® 5811 applied to protect all external surfaces of the pipeline.

Belzona® 4211 effectively sealed live leaks without interrupting operation of the skimmer which prevents oil pollution of the sea.
