## CREATING CUTLASS BEARINGS WITH BELZONA

Water/Electricity Authority in Qatar

Water lubricated cutlass bearings from sea water lift pumps

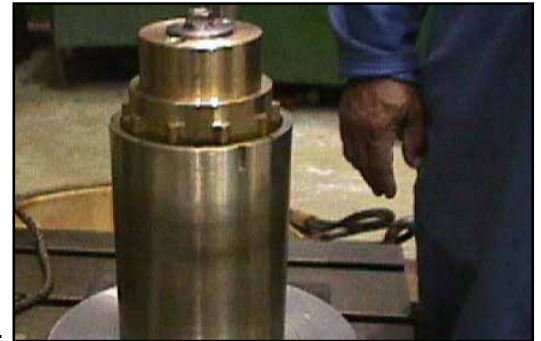
1. Accurate mold created to form the bearings
2. Belzona Elastomer being poured into the mold
3. Completed bearing
