BELZONA PROTECTS FANS FROM ABRASION

Tobacco company, Egypt

Suction fans

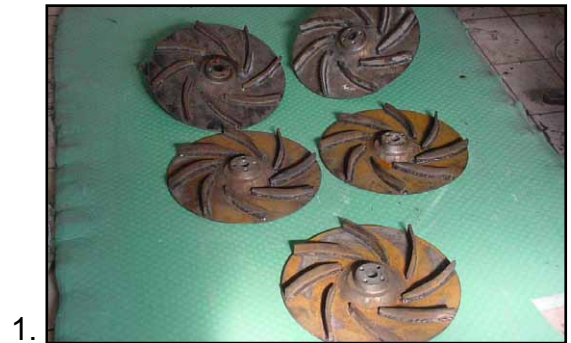
The fans need to be protected from strong abrasion of tobacco which has worn the fans out in only three months.

1. General view of tobacco suction fans
2. Fans following surface preparation
3. Fans coated with Belzona® 1812
4. Five fans were protected
