BELZONA REDUCES FUEL CONSUMPTION OF A HIGH SPEED PASSENGER FERRY

Jet drive coating on high speed passenger ferry.

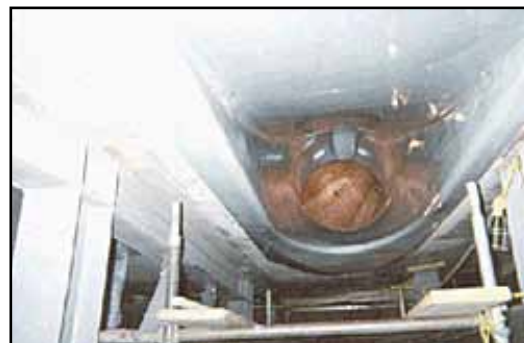
1. An overview of the passenger ferry
2. View of jet inlet (1st coat of Belzona® 1341)
3. View of outlet coating complete
4. View of inlet (2nd coat of Belzona® 1341)

Original specified coating material actually decreased the efficiency of the jets. Increase in jet drive efficiency sought to reduce fuel consumption and increase speed.

Belzona has an approval by KaMeWa North America as well as an ABS approved procedure for Jet drive coating. An overall increase in speed was achieved as a result of the Belzona coating.
